Cessna
A Textron Company

Service Bulletin

April 16, 2007 SEB07-2

ENGINE MOUNT BRACKET INSPECTION

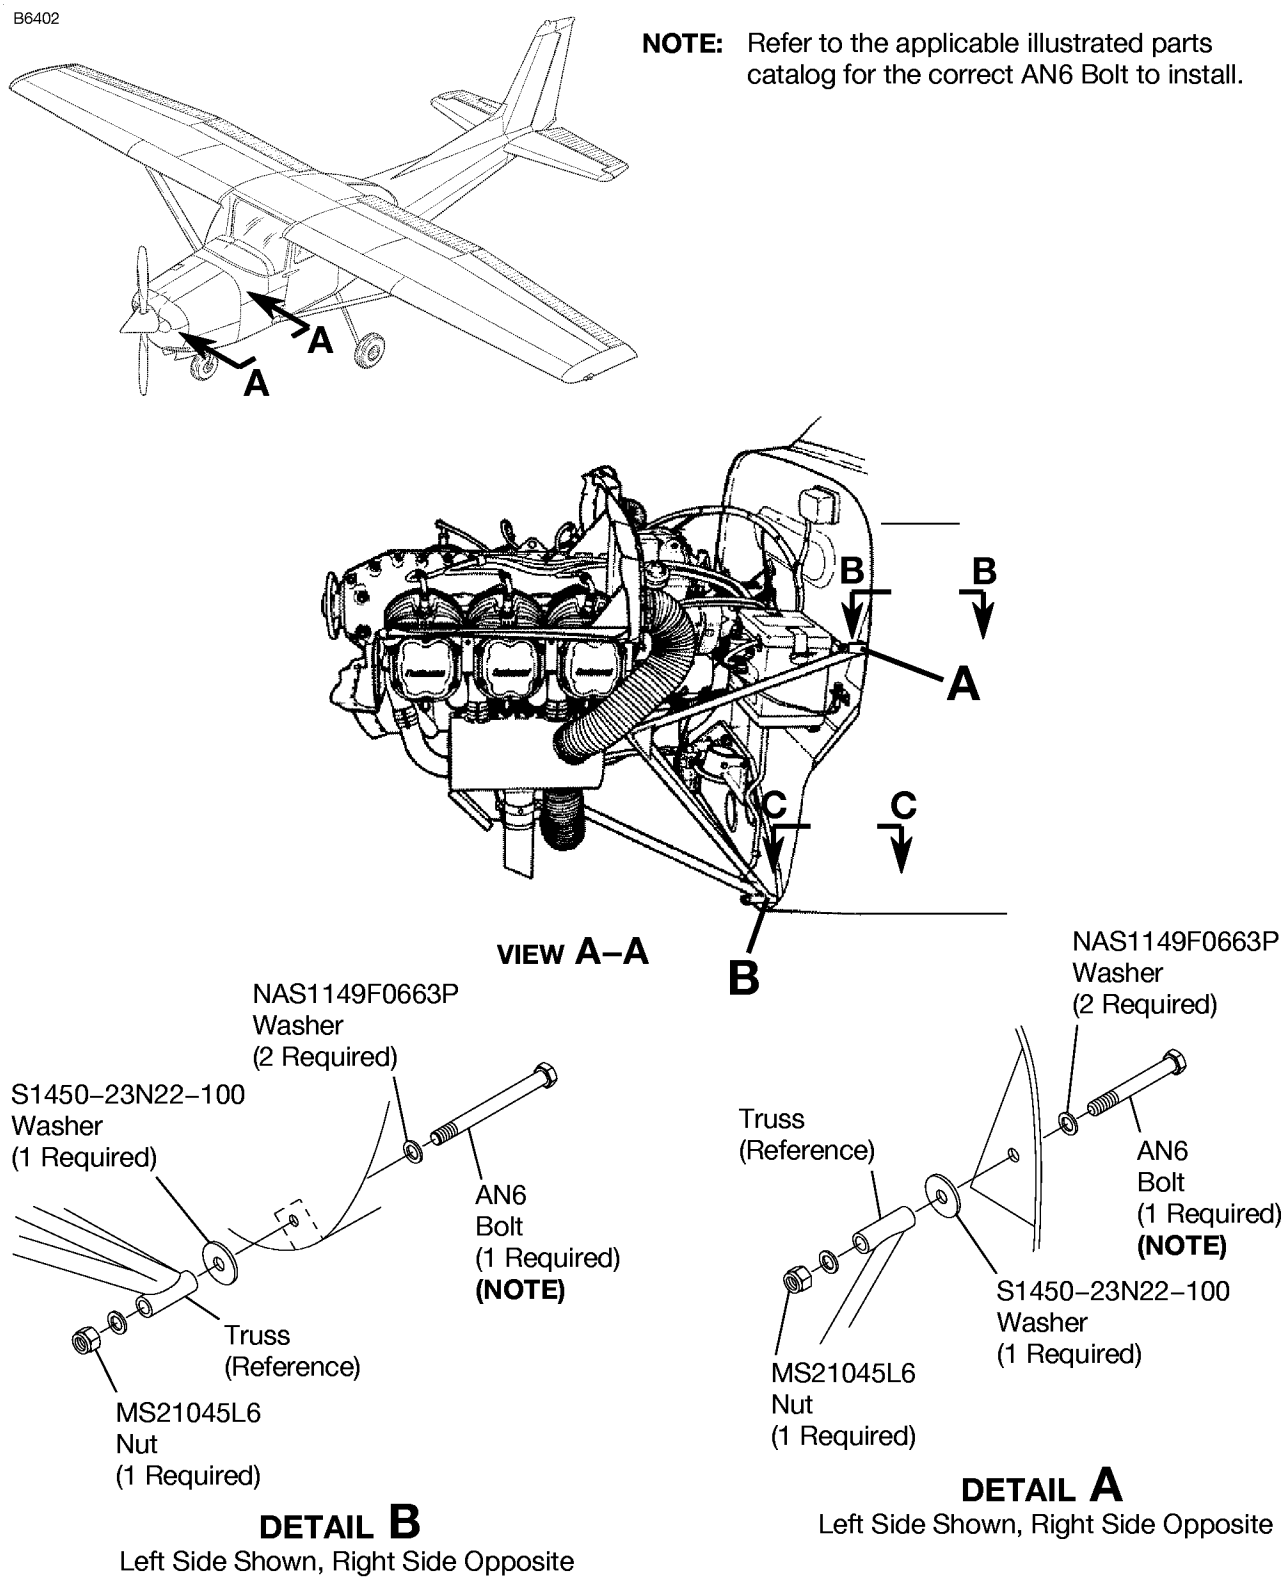
Figure 1. Engine Mount Bracket Inspection (Sheet 1)

Reports have been received of cracks being found in some upper and lower engine truss mounting brackets that are installed behind the firewall. This Service Bulletin provides instructions to do an inspection of the brackets, and if necessary, to replace the brackets. Non compliance with this Service Bulletin could result in having less than the desired structural integrity of the upper and lower engine truss mounting brackets.

For Model 172 thru 172N, R172K, FP172, F172D thru F172N, and FR172E thru FR172K Airplanes

4. Use an engine hoist to remove all of the engine weight from the engine truss.
5. Do an inspection of the left 0513132-11 Upper Mounting Bracket:
   A. (Refer to Figure 1, View A-A and Detail A.) From a position under the instrument panel, move the wires and the insulation away from the bolt that attaches the upper left engine truss to the left 0513132-11 Upper Mounting Bracket.
   B. Remove and discard the bolt, washers, and nut that attach the truss to the left 0513132-11 Upper Mounting Bracket.
   C. (Refer to Figure 1, View B-B.) Put a borescope through the slot in the 0513132-7 Upper Left Stringer.
   D. (Refer to Figure 1, View D-D.) Look carefully for a deformed or cracked left 0513132-11 Upper Mounting Bracket.
      (1) If you do find deformities or cracks, go to Step 5E.
      (2) If you do not find deformities or cracks, go to Step 6.

E. (Refer to Figure 1, View B-B.) Remove the left 0513132-11 Upper Mounting Bracket from the 0513132-7 Upper Left Stringer and the airplane skin.

(11) (Refer to Figure 1, Detail A.) With the AN6 Bolt, S1450-23N22-100 Washer, two NAS1149F0663P Washers, and MS21045L6 Nut, attach the upper left engine truss to the left 0513132-11 Upper Mounting Bracket.

B. (Refer to all applicable details and views in Figure 1.) Do Steps 5B thru 5F again for the 0513132-10 Lower Right Mounting Bracket and the 0514132-9 Lower Left Mounting Bracket as necessary.

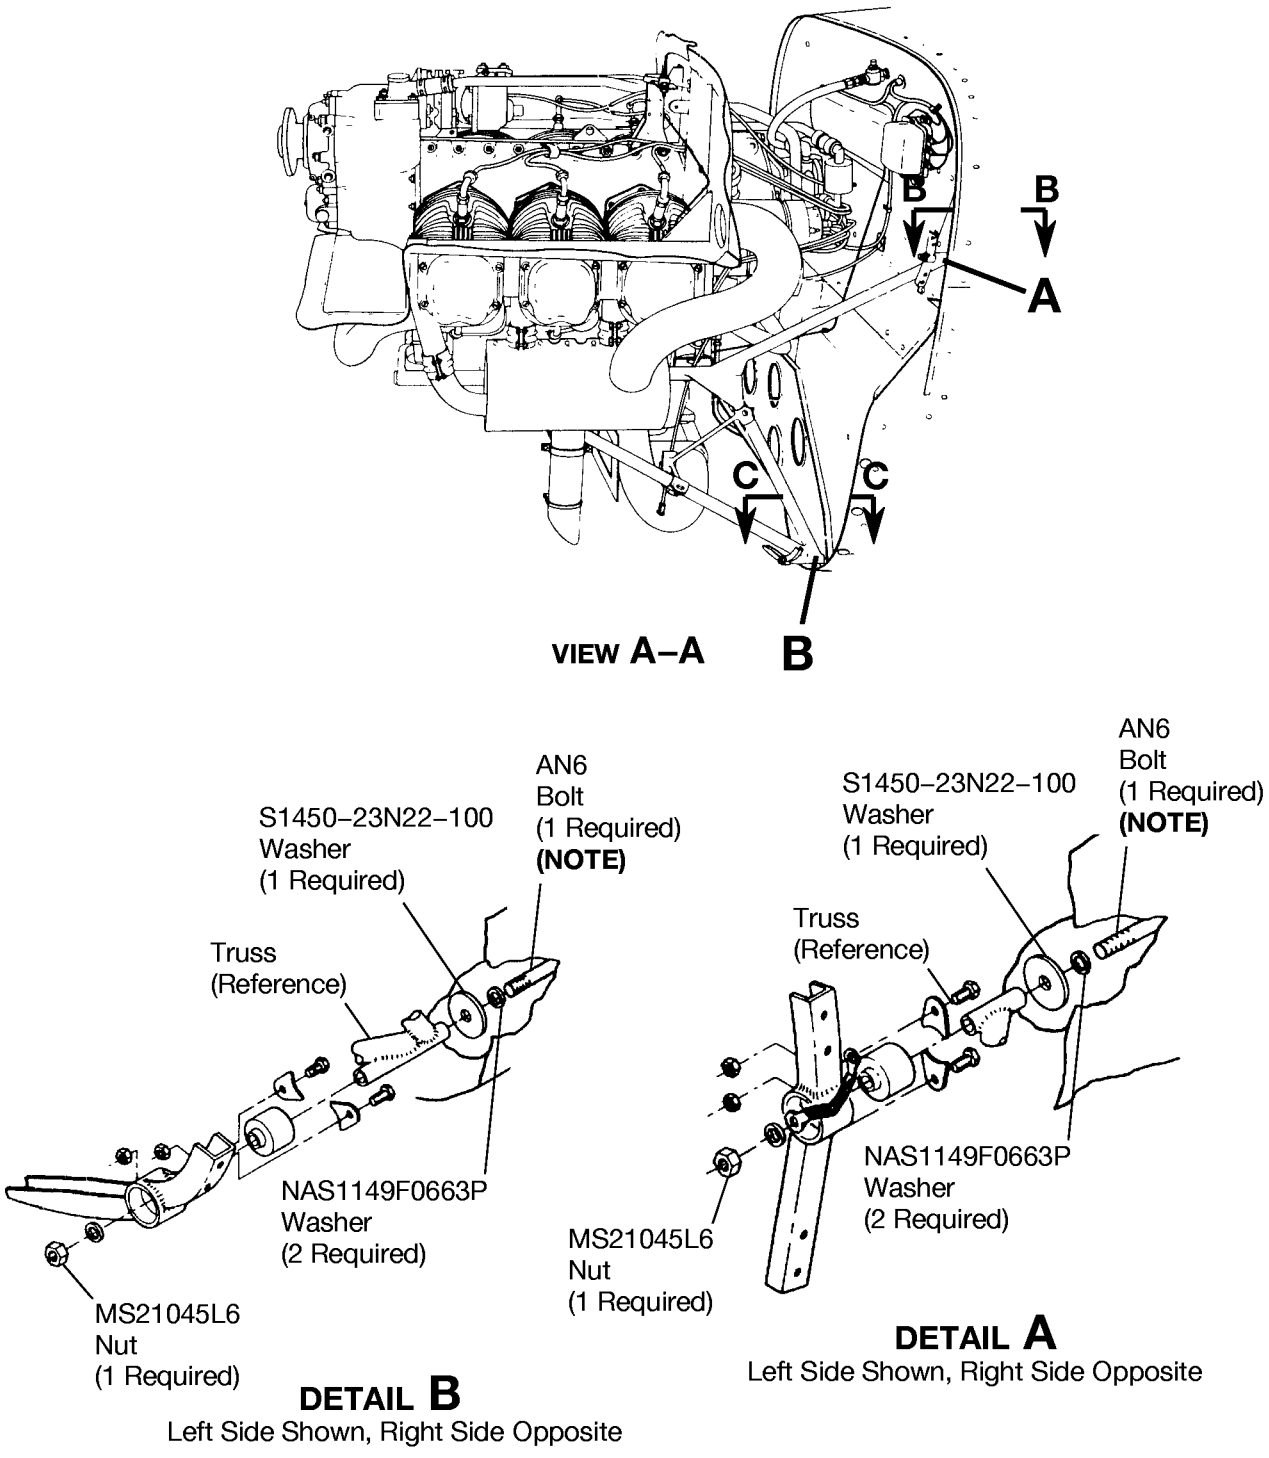
Figure 1. Engine Mount Bracket Inspection (Sheet 2)

For Model 175 thru 175C and P172D Airplanes
